## Wide Open World – Tech Tip How performance craters when defective power supplies, power throttling and BIOS settings intersect! Copyright © 2017 SAS Institute Inc. All Rights Reserved.

Version: 201701131500gcmA - \*\*\* RFC / Final \*\*\* By Gregory Mobley, gregory.mobley@sas.com

**BLUF:** Lenovo/IBM issued an Engineering Change Announcement, ECA-003, to replace defective power supply units (PSU). Server models in ECA-003 should be inspected. If defective PSUs are installed, then follow the instructions to replace them. Be prepared to provide the make, model, serial and IMM logs with screen captures of the PSU serial numbers to identify the defective PSUs.

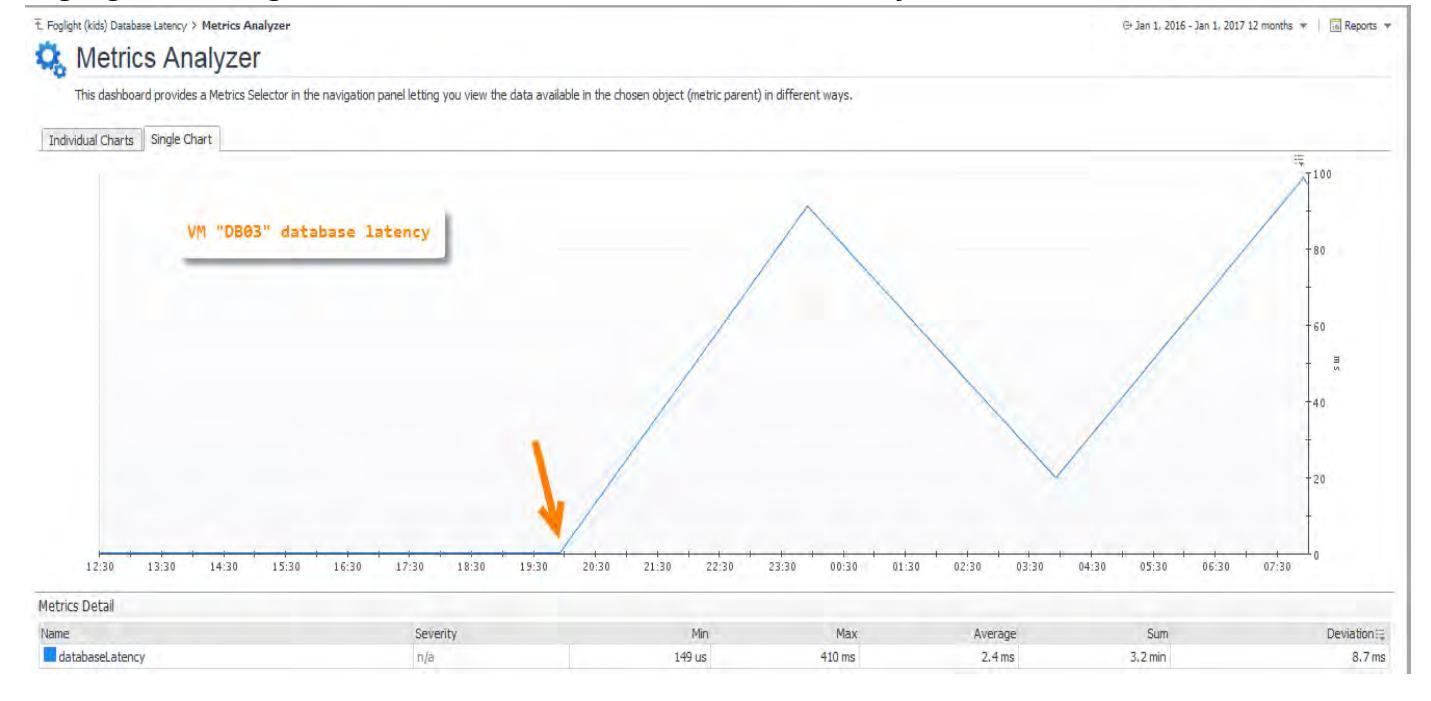
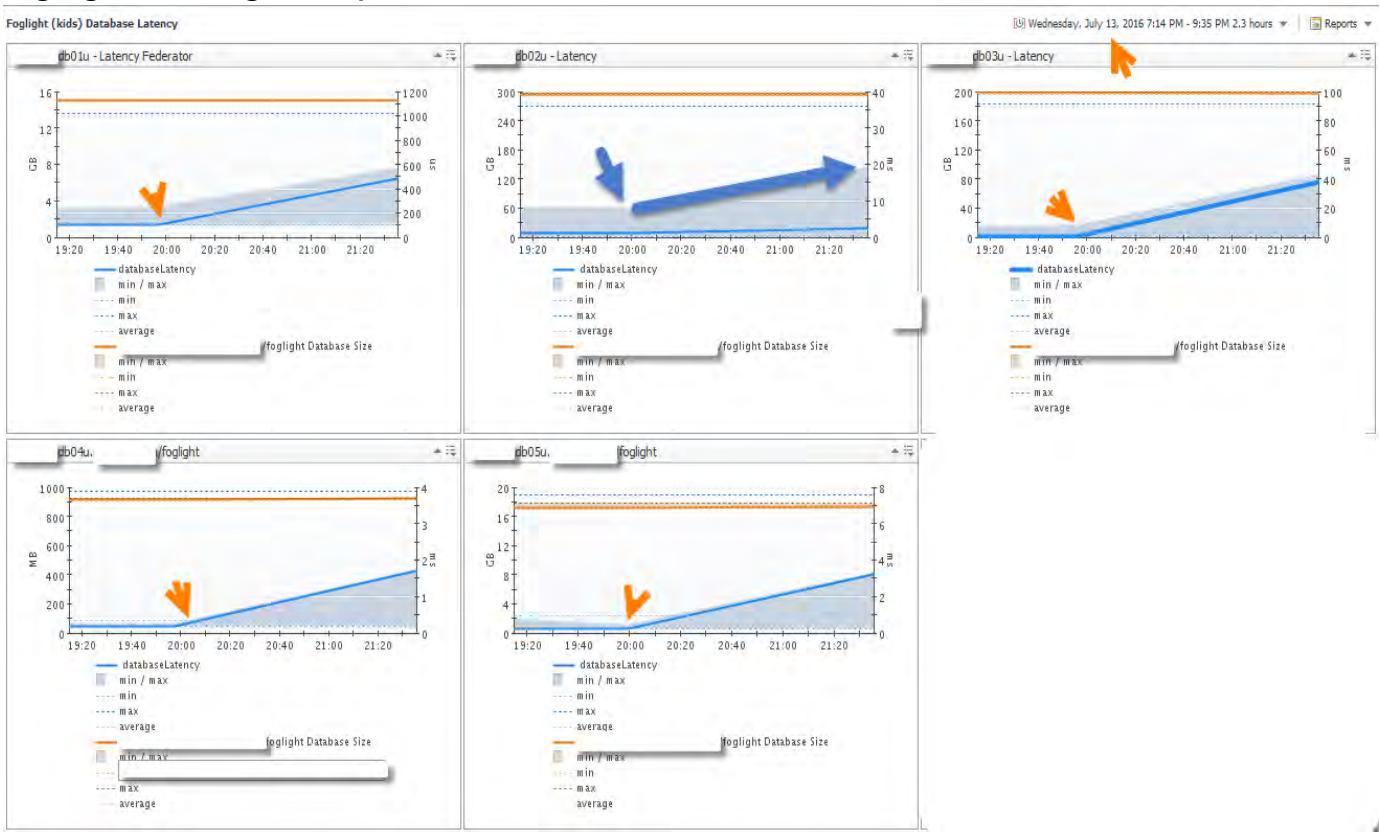
# Foglight showing steep increases in multiple VM database latencies

Foglight showing a drill-in on VM DB03 database latency 20:00 13 Jun 2016

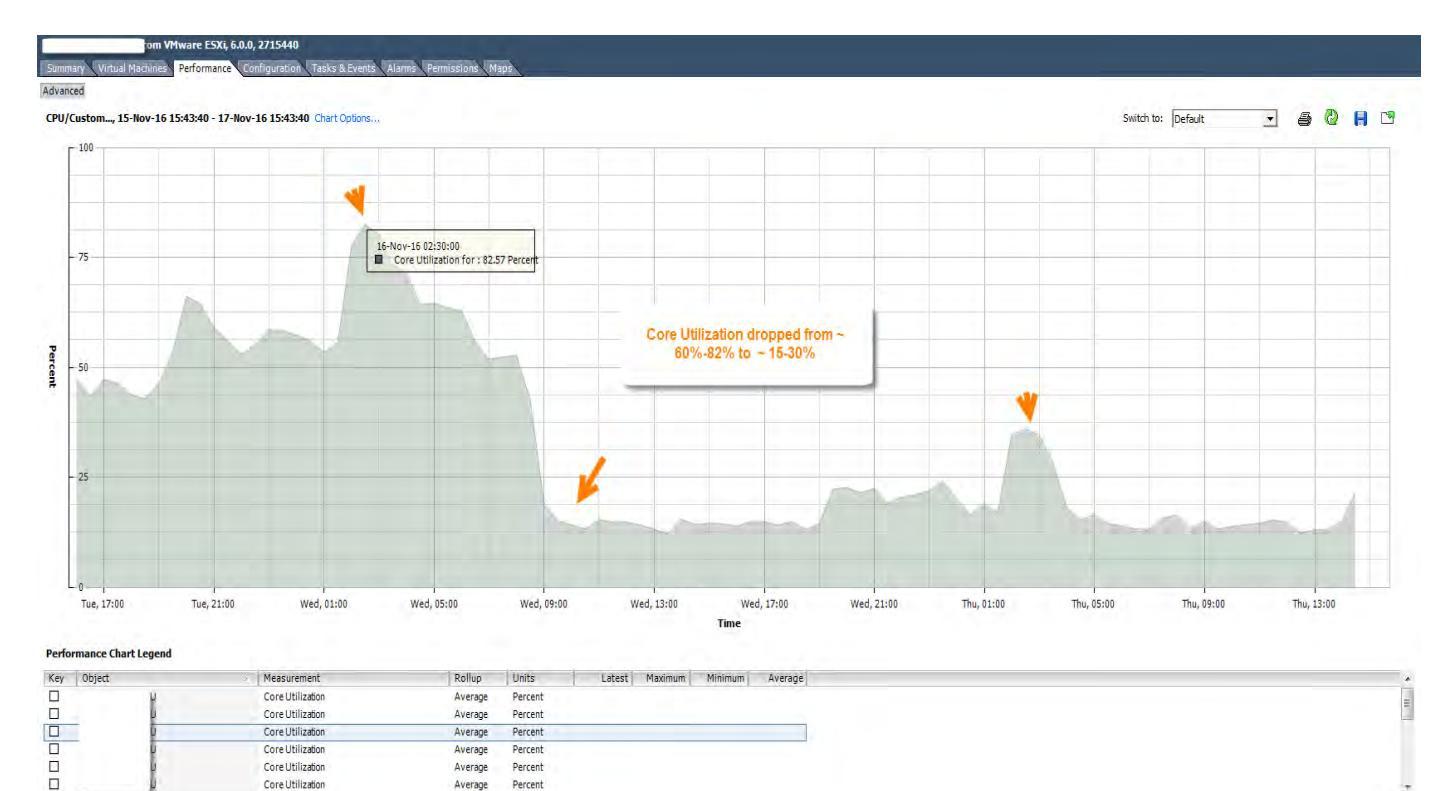
#### VMware showing pHOST "Core Utilization" with 82% peaks during throttling vs. 30% peaks when not throttled and using HOP BIOS settings

The GUI sluggishness, as reported by customers, is to be expected on overallocated pHosts. Given the left-most graphing below, engineers may conclude the pHW pCPUs are being challenged by the active workloads and that ordering new pHW is imperative to restore performance. However, when viewing the right-most graphing, those same engineers would conclude the pHOST is modestly loaded.

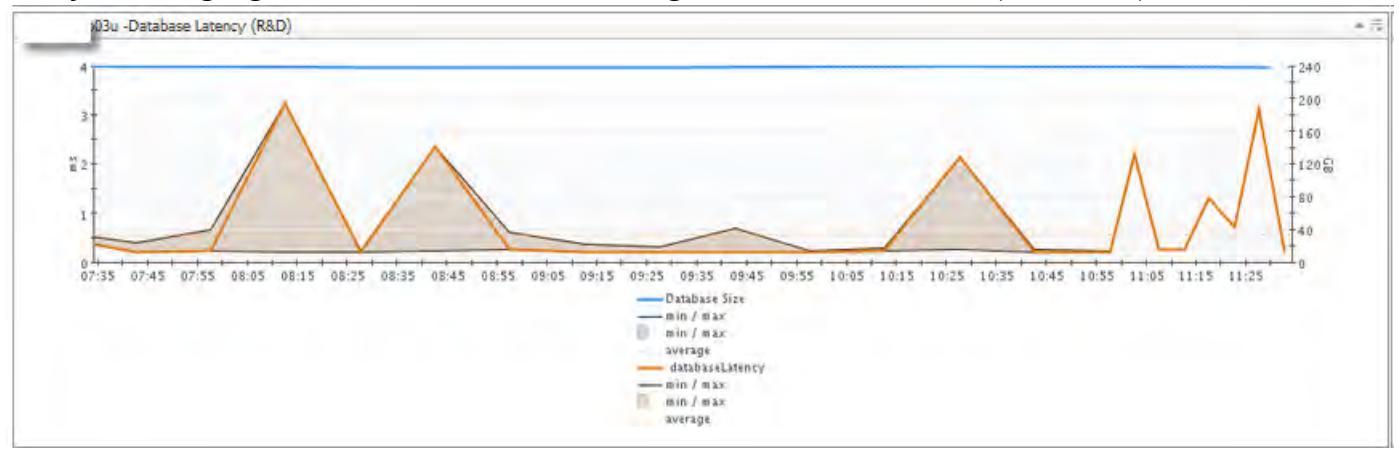
# Foglight showing multiple VM database latencies with no throttling and HOP BIOS settings fully engaged.

Today our Foglight database latencies range from 400us - 3ms (4hr view)

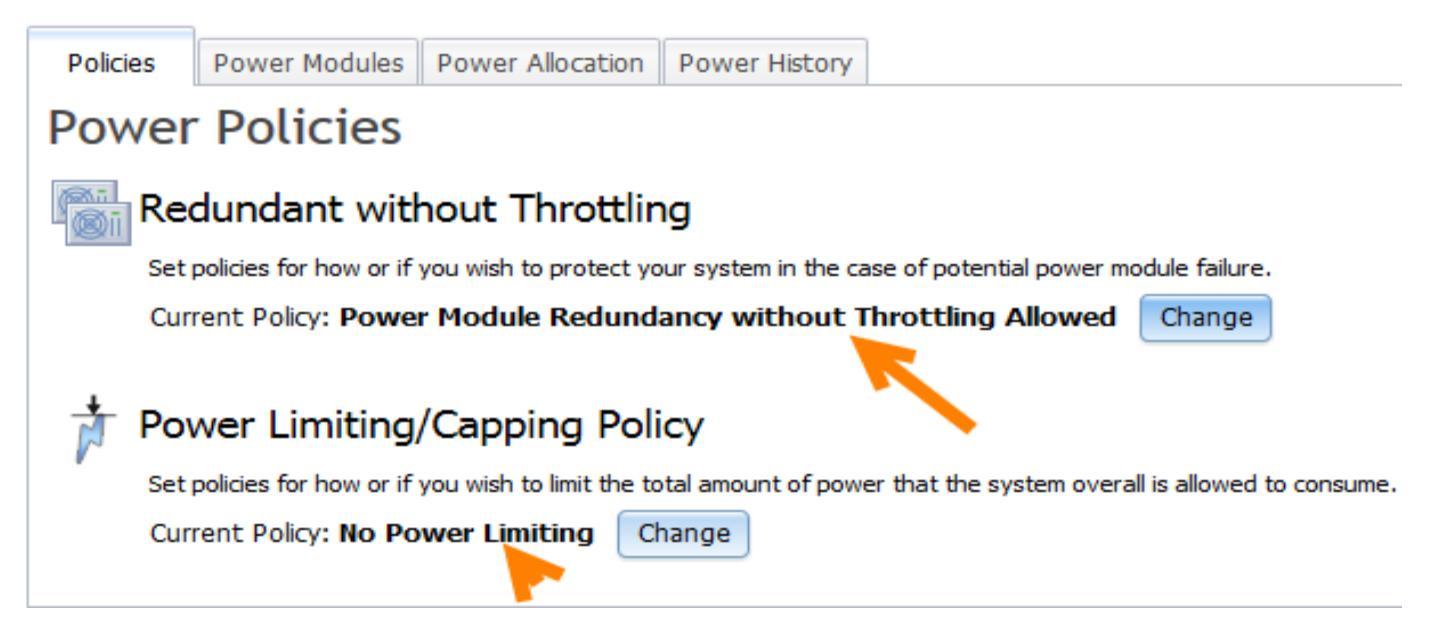
"Power Policies" are features which may be available from many hardware manufacturers. Often, the Power Policy defaults to allow power throttling. These policies should be changed in the IMM Power Management section. The policies and defaults may not update when redundant power supplies are installed. Do not assume, verify your system settings!

#### Select "Redundant without Throttling"
